**Cold Regions Research  
and Engineering Laboratory**

**ERDC/CRREL TR-03-11**

**US Army Corps  
of Engineers®**  
Engineer Research and  
Development Center

## **Remote Assessment of Army Tactical River Crossing Sites Using LIDAR Imagery**

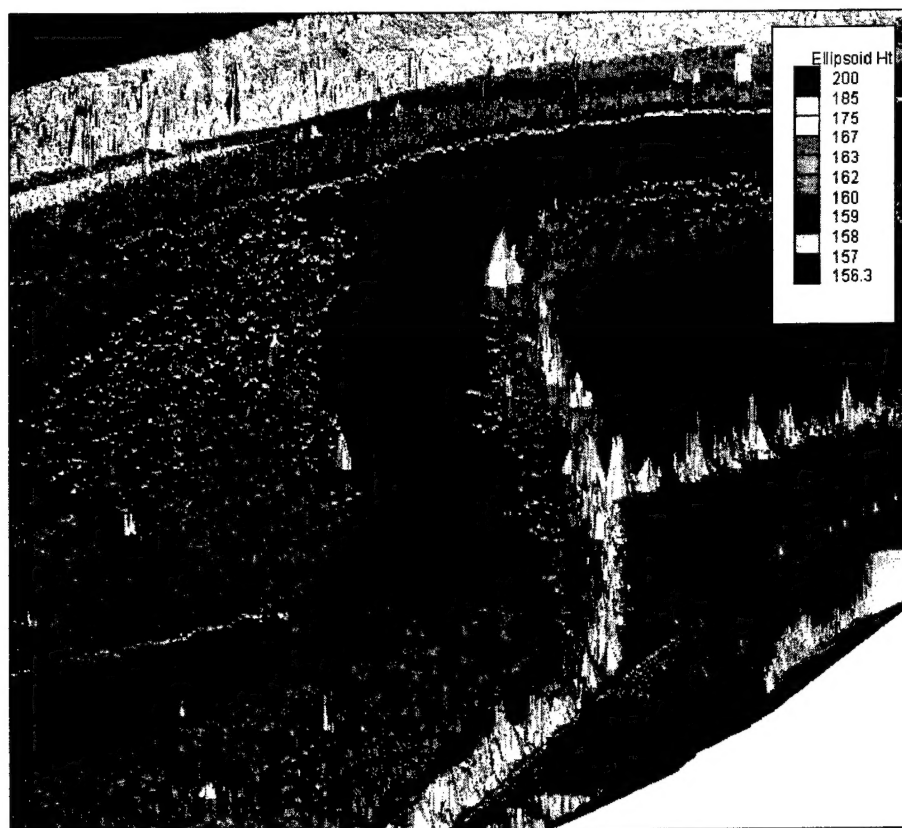
Figure A45. Site 19 ALSM looking north.

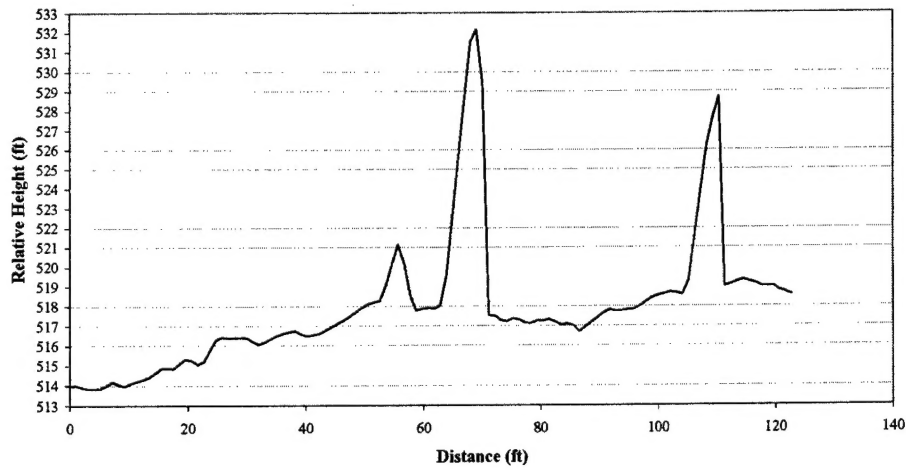
**Figure A46. Site 19 east bank. Distance 0 is at water. The two tall spikes at about 70 and 110 feet are vegetation. No ground survey data available.**

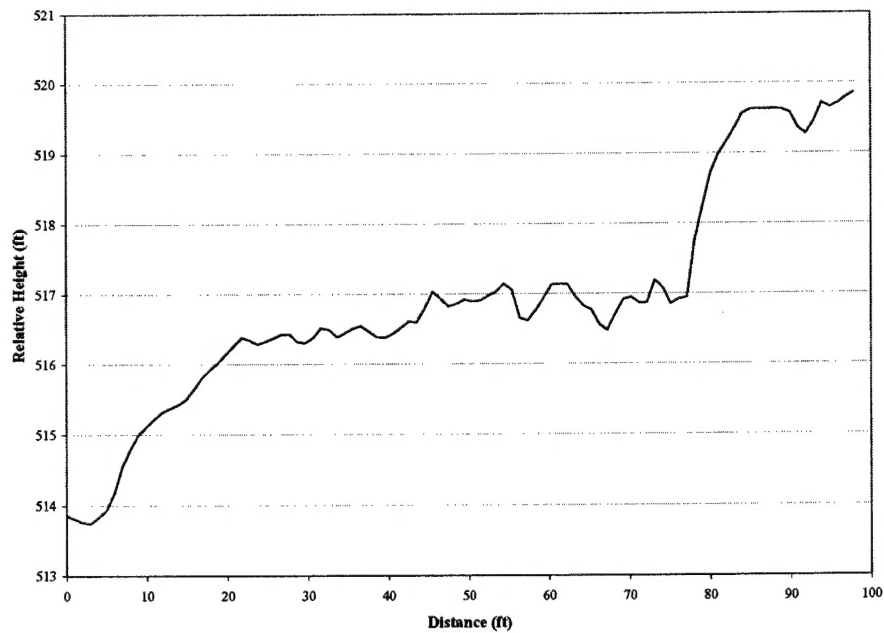
**Figure A47. Site 19 west bank. Distance 0 is at water. No ground survey data available.**

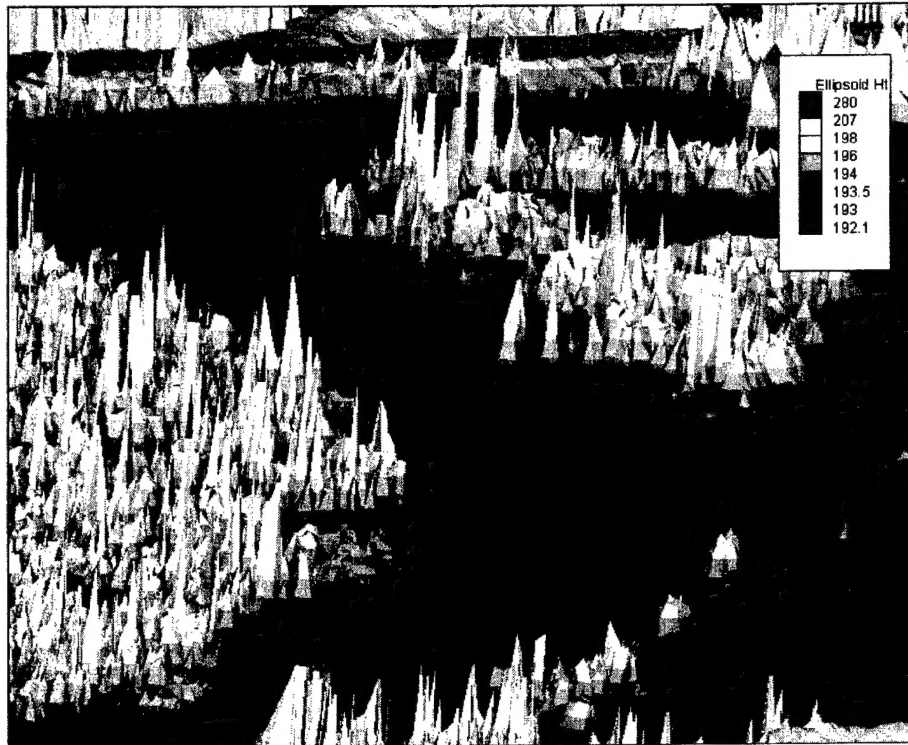
Figure A48. Site 20 ALSM looking southeast.

At the top of the east bank is a short section of bank about 1.5 feet high at 67°. It was felt that this section on an already steep slope would be difficult, if not impossible, to traverse and was the reason for classifying this crossing as marginal. The on-site inspection found that the slope of this section actually approached 90° with the steep section being about 2 feet high and therefore not trafficable. The discrepancy of the DEM profile at the near-90° section seems characteristic of the technique and is illustrated further below. Figure 10 shows the DEM from Site 20.

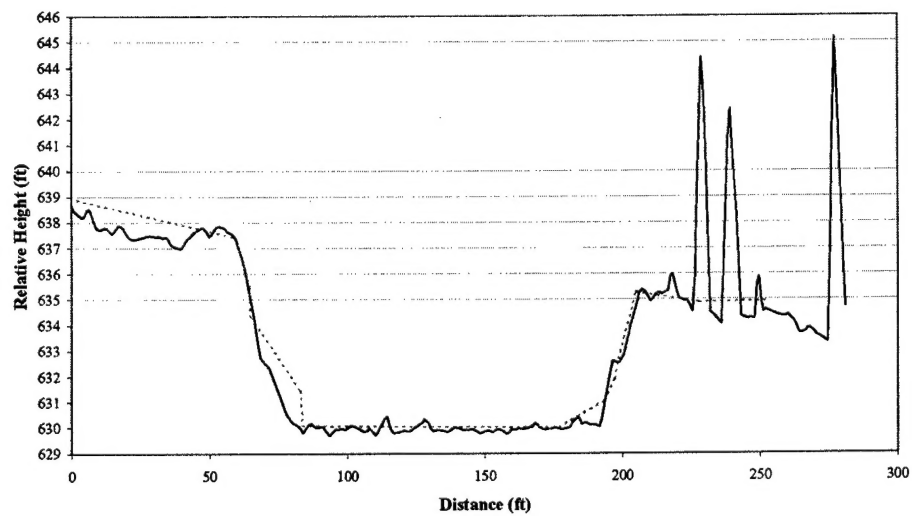
Figure A49. Site 20 ALSM and survey comparison. Distance 0 is on the southwest bank. The water surface is from about distance 85 to 190 feet.
